FACILITY	DATE
Sample Building	17/03/2004

Location: 2nd Floor Lobby Roof Column

INFRARED IMAGES

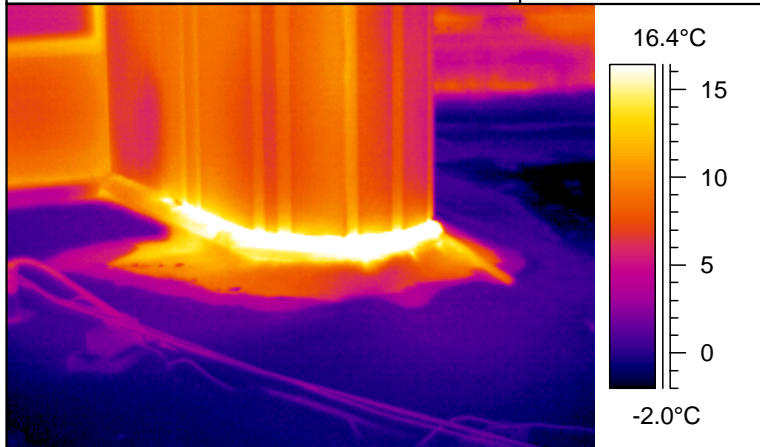
Condition:

Pressurized

Notes:
 Infrared images of precast nosing at the 2nd floor lobby roof. North-West corner of building.
 Building pressurized with building intake fans. Exhaust fans off.

Heat loss noted during pressurized state only.
 Suspect air leakage at location.

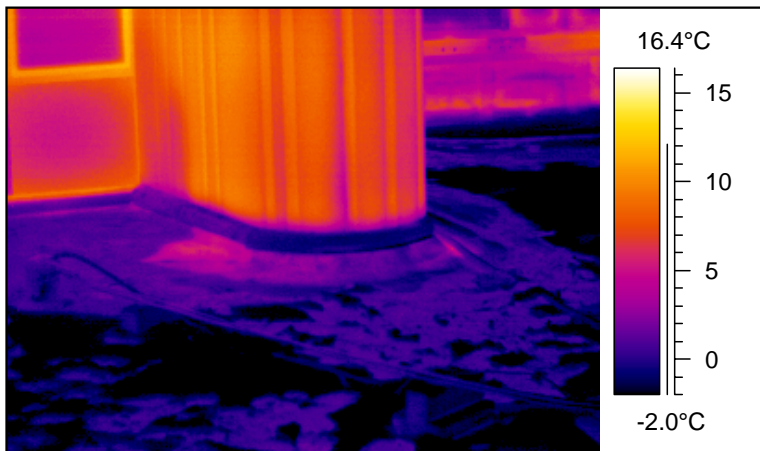
Condition:

Depressurized
