### Ice Rink Leak Location with Thermography

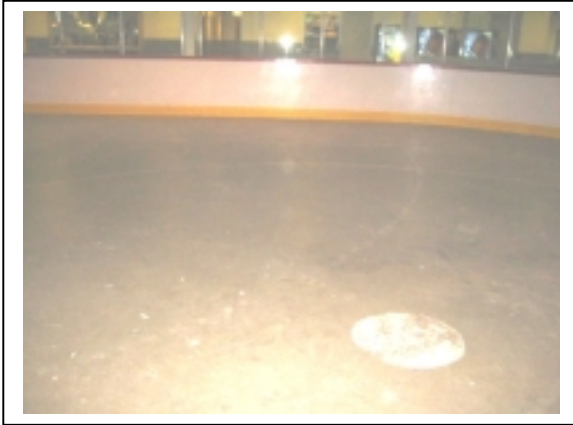
Typical ice pad surface. Ice removed with a cement floor surface.

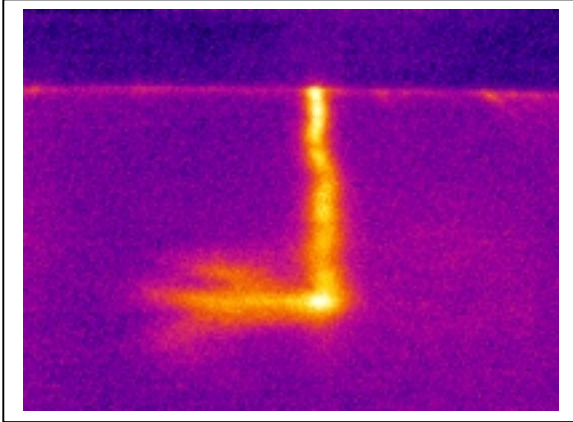
Infrared image of the ice pad cement floor surface. Same location as in the photograph. Thermography can see the small temperature difference cause by the embedded leaking pipe. Indicated here is the leaking pipe installation and a temperature rise plume at the leak location.

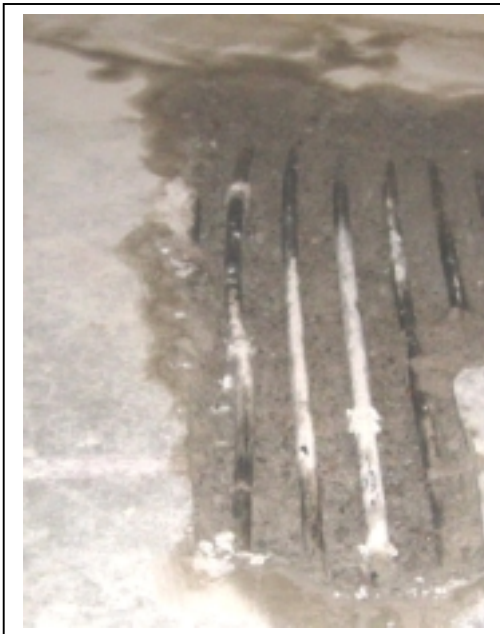
A leak was exposed and confirmed at the suspect location. Shown here are the exposed sub-surface ice pad cooling system piping.

Thermography can be used to continue monitoring the surface for other smaller leaks. Varying times may be required to locate all leaks. The infrared images showed exact pipe installation location as well as a temperature rise plume at the actual leak location. The concrete was broken up and inspected at each suspect leak location. Confirmed leaks were noted at each location. Repairs to both leaks were completed and the cooling system returned to service. No further significant dropping of coolant levels were noticed.
