Boldstar Infrared Services Helps Zoo Staff with Ailing Elephant

Pachyderm Leg Ailment Diagnosis with Infrared Thermography

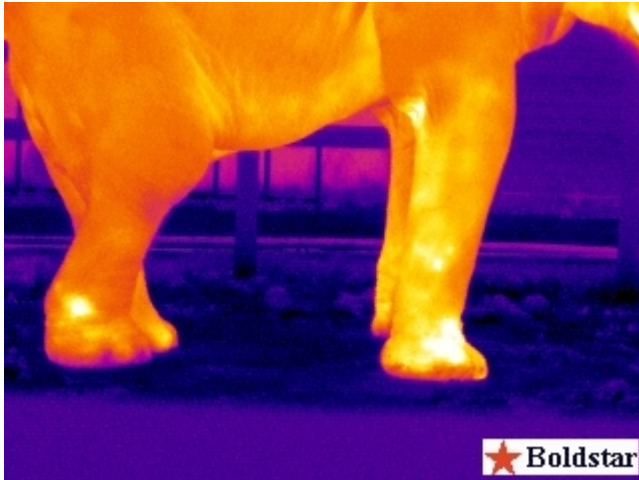
Update: Further inspection of the identified lower foot region found that Vance had a dislocated toe. The ailment was then treated normally and Vance is well on his way to recovery.

elephant right side
- inflammation located in front right leg, specifically the lower foot area.

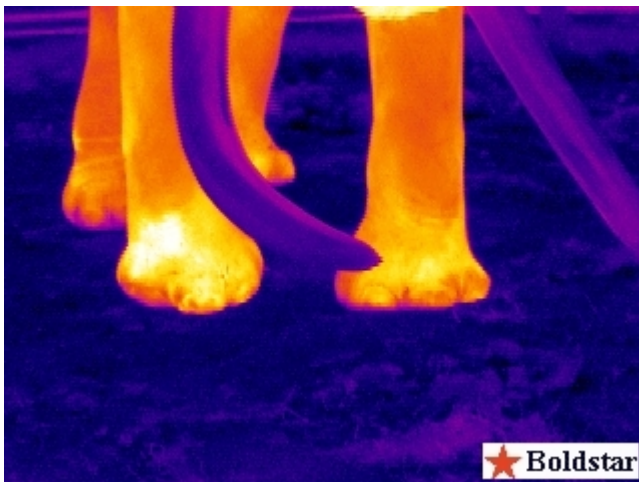
elephant front feet
- thermography proved excellent for comparing foot conditions. Here the front right foot is easily compared to the left foot. Problem area is the right lower foot area (white section)

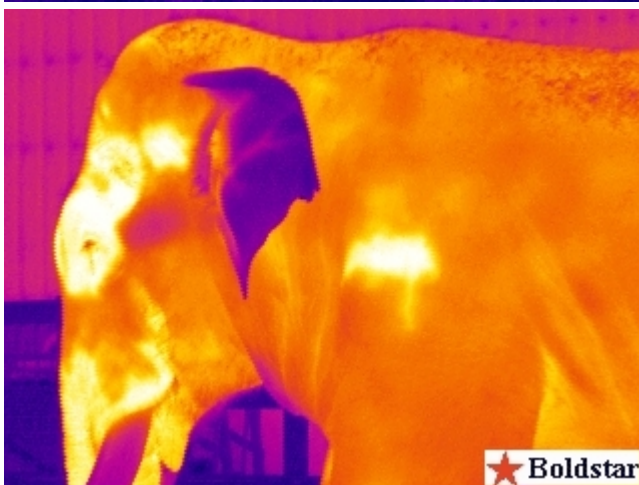
front left hip
- elevated front left hip temperatures noted. Suspect cause: left hip and leg taking weight not supported due to front right foot problem.
