FACILITY	DATE
Sample Building	June 26/ 01

Location: East Wing, North Edge

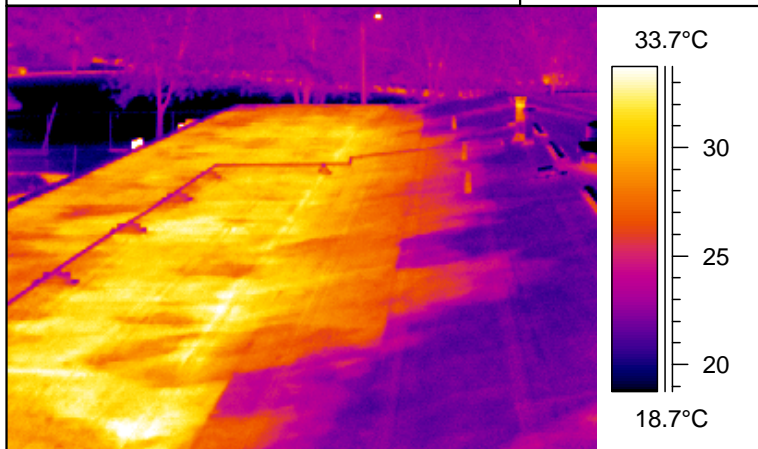
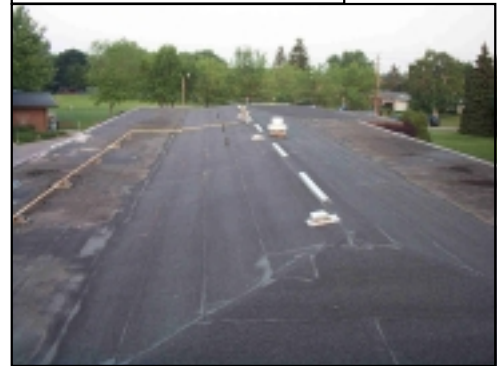
Area # 1- Identified at time of inspection with spray paint. See roof layout drawing.

Infrared image of East wing at North edge.

Moisture infiltration found (yellow/ orange area in image)

Total area wet: 25 feet by 160 feet= 4000 square feet.

Total area of East Wing- approx 8400 square feet.

This area verified wet with Delhorst moisture probe- 100 % full scale
