DESCRIPTION	DATE
200 HP Motor	Dec. 21/04

Identification: Dust Collector # 5

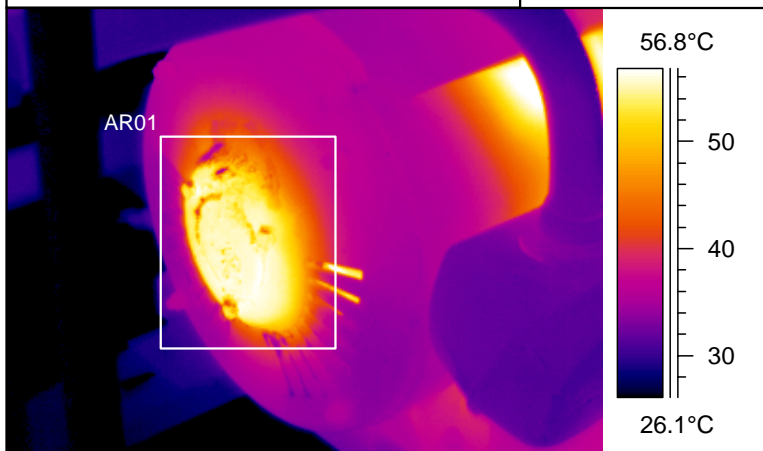
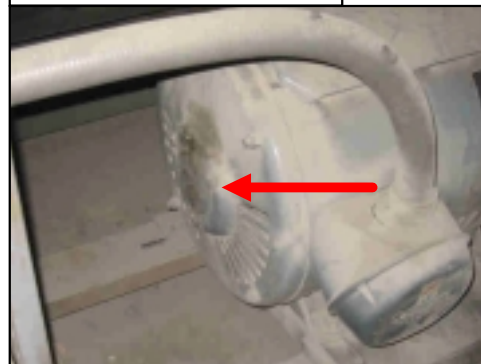
INFRARED IMAGE

IR information	Value
Date of creation	21/12/2004
Object parameter	Value
Ambient temperature	19.0°C
Label	Value
AR01 : max	58.2°C

Motor current: 56 A, 57 A, 57 A

Infrared image of the dust collector # 5 drive motor.

Heating noted at the rear (outboard) bearing (at arrow in photo).

Heating rear bearing
