FACILITY	DATE
Sample Location	16/02/2004

Location: Living Room- Below Windows

## INFRARED IMAGES

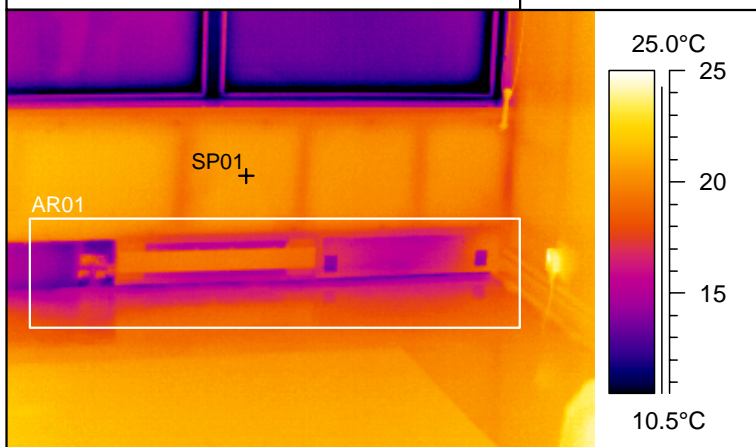
Condition:

No Pressure

IR information	Value
Date of creation	16/02/2004
Time of creation	7:25:30 PM
Object parameter	Value
Ambient temperature	21.0°C
Label	Value
SP01	20.6°C
AR01 : min	12.0°C

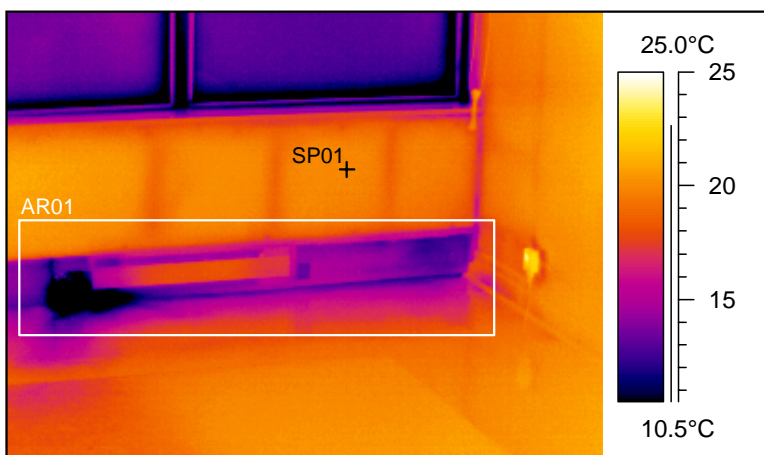
Condition:

Negative Pressure

IR information	Value
Date of creation	16/02/2004
Time of creation	7:40:24 PM
Object parameter	Value
Ambient temperature	21.0°C
Label	Value
SP01	19.8°C
AR01 : min	0.3°C

Concentrated cold areas at the holes in the block wall and at the south demising wall (right side) indicate air leakage.

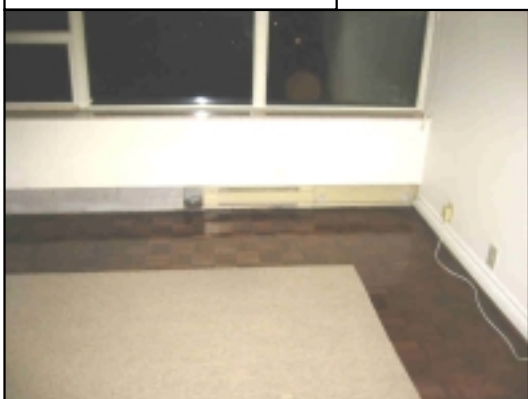
## Photo

Notes:
