FACILITY	DATE
Sample House: Exterior	Jan. 18/05

Location: North Turret Windows

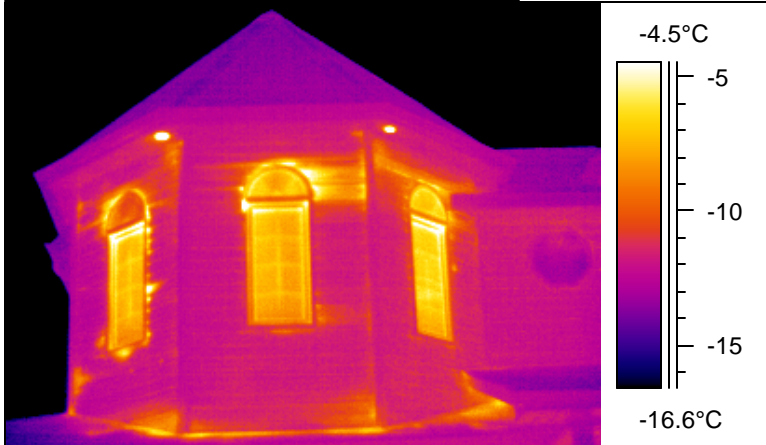
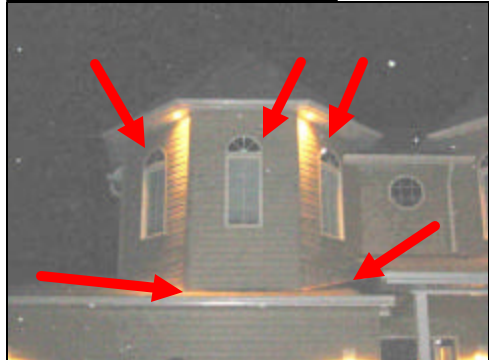
Infrared image of the exterior view of the north turret windows.
 Heat loss noted around all shown windows and along the bottom of the turret.
 (at red arrows in the photo)

Suspect: poor window installations. Missing or reduced insulation at location. Air leakage at location.
 Inspect further to verify cause.
