FACILITY	DATE
Sample House: Interior	Jan. 18/05

Location: Basement, Cable Penetration

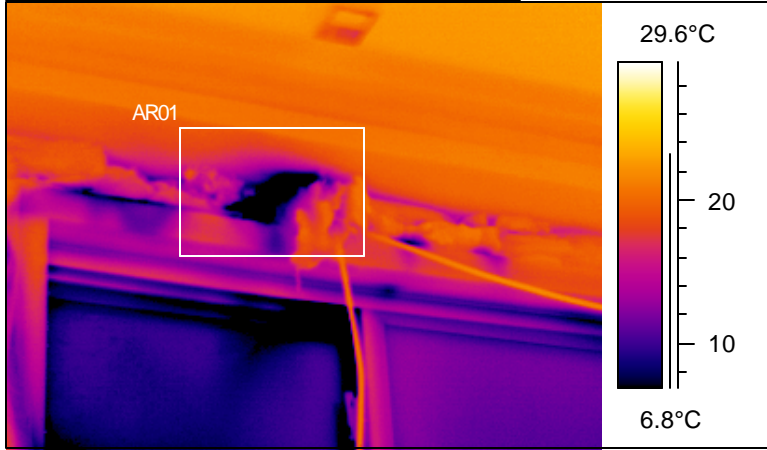
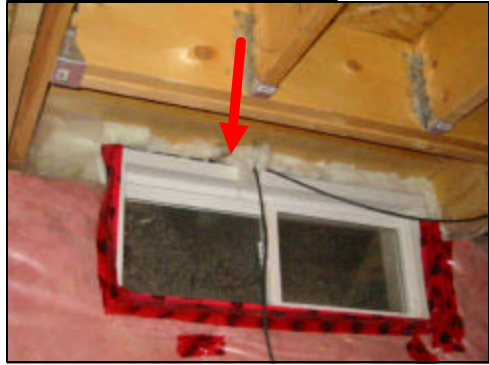
IR information	Value
Date of creation	18/01/2005
Time of creation	7:09:08 PM
Object parameter	Value
Ambient temperature	23.0°C
Label	Value
AR01 : min	-5.5°C

Infrared image of the cable penetration on the south wall in the basement.
Cold section noted, at arrow in photo.

Suspect: cold air ingress at location.
Inspect further to verify cause.

See IR information chart above for minimum temperature inside area box.
